Axle Service Manual

950 Series Drum Brake 37spline

External Drum, 420mm x 180mm

80260 REV D

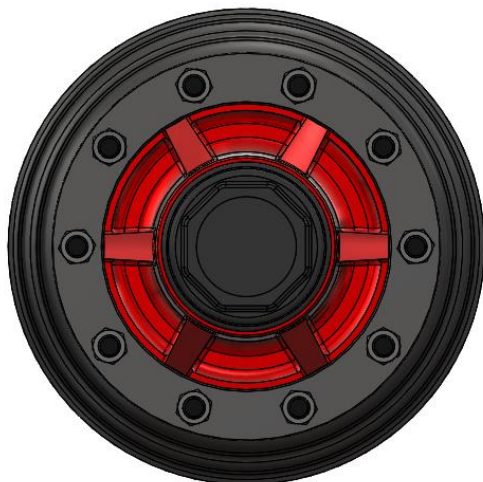
Undo the Hub cap

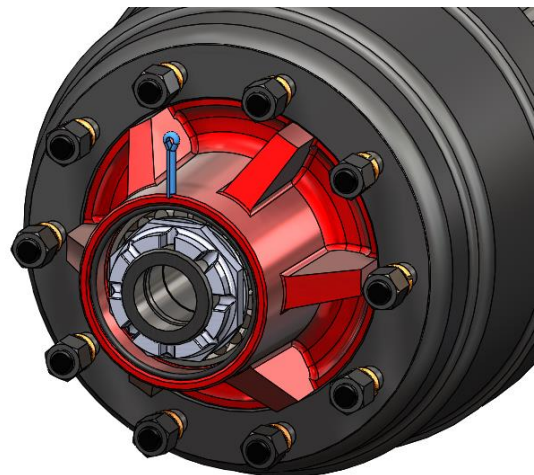
Straighten cotter pin tab's & remove it

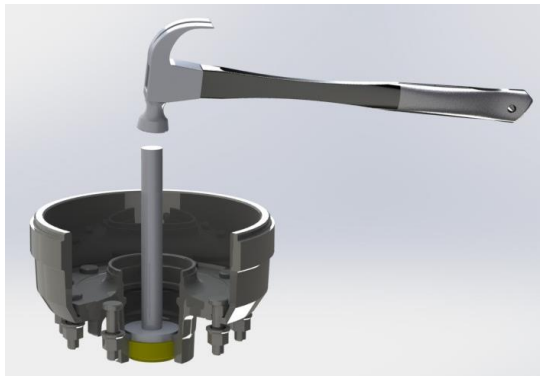
Outer bearing cone being removed.
